# PVC AND STEEL ACCESS TUBE DEBONDING DURING SONIC LOGGING TESTING FOR THE SC 170 BRIDGE REPLACEMENT PROJECT

Edward L. Hajduk, WPC, Mt Pleasant, SC  
Donovan L. Ledford, WPC, Mt Pleasant, SC  
William R. Christopher, WPC, Mt Pleasant, SC

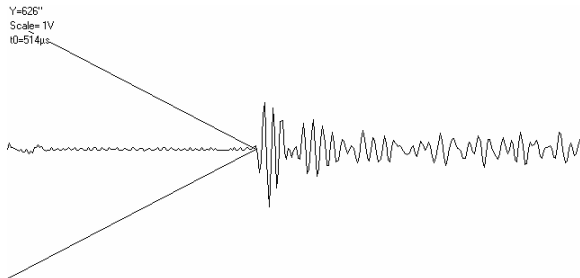
Figure 3. Typical CSL signal across shaft.

at various distances from the shaft top. These distances extended up to 12.2 meters (40 feet) from the shaft top, which was approximately 40% of the shaft length for the tested shafts. The erratic sonic signals consisted of increased First Arrival Times (FAT) and decreased relative energies (RE) within the CSL results. Typically, although not always, major principal diameter and near major principal diameter combinations during CSL testing experienced a complete loss of signal within these zones. Figure 3 shows a typical major principal diameter CSL signal along the shaft, while Figure 4 presents a typical CSL signal near the top of the shaft.

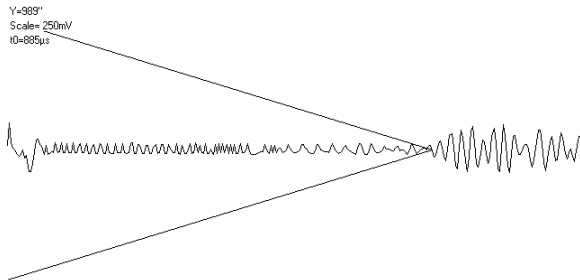
Figure 4. Typical CSL signal within the upper portion of the same combination for the same shaft.

Based on previous CSL testing experience, it was believed that these erratic signals were due to access tube debonding. Access tube debonding is the separation of the access tube from the surrounding concrete and/or weakening of the interface between the two materials. Typically, access tube debonding occurs when polyvinyl chloride (PVC) pipe is used in place of steel, although debonding can occur when steel tubing is used. As the concrete cures, the heat of hydration causes increased temperatures with the drilled shafts. This increased temperature causes the access tubing to expand. As the concrete cools, the access tubes contract, cause

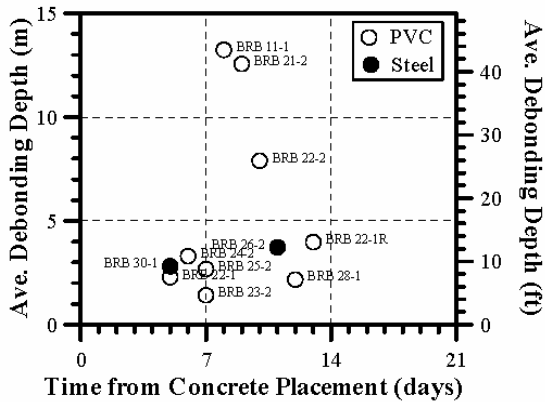
Figure 5. Average Debonding Depth vs. Elapsed Time from Concrete Placement – Initial CSL testing.

As shown in Figure 5, three drilled shafts had average access tube debonding depths greater than 7.56m (25ft). These shafts corresponded to those shafts in which water was not placed in the access tubes immediately after concrete placement.

- Average depth to debonding observed during CSL testing within 7 days of concrete placement does not significantly vary between PVC and steel access tubes for access tubes filled with water after concrete placement. However, it was noted that this was based on a limited number of shafts with steel access tubes.
- After 7 days, average debonding depth varies greatly within PVC access tubes.
- For steel access tubes, debonding does not significantly increase with time up to the time tested.

- PVC access tubes would be adequate for use provided that sonic logging testing is conducted between three to seven (3 to 7) days after concrete placement. Testing within this timeframe should limit debonding to the upper 10 feet. Sonic logging testing should not be conducted prior to three (3) days from concrete placement.

- Hybrid PVC/steel access tubes should be installed within the shafts if debonding depths of 10 feet are not acceptable. A sturdy connection between the PVC and steel capable of withstanding the stresses associated with installation should be used. If this alternative is selected, steel tubing should be used within the upper 40 feet of the shaft followed by PVC tubing to the shaft bottom. CSL testing should be conducted within 3 to 14 days for combination access tubing.

- If hybrid access tubes are not used, then both steel and PVC access tube should be installed within the shaft. The PVC access tubes should extend along the entire length of the shaft, while the steel access tubing should be installed to a depth of 40 feet. All access tubes should be spaced equidistant around the shaft.

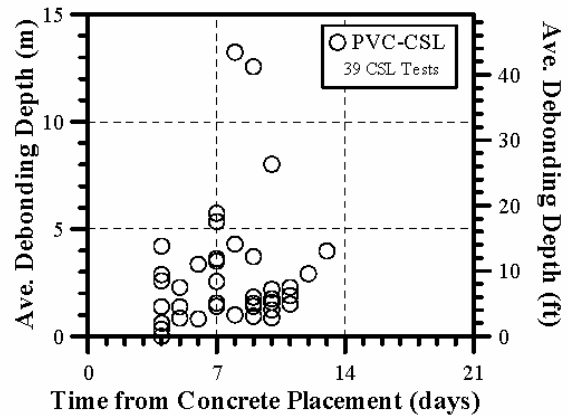
Figure 7. Average Debonding Depth vs. Time (PVC-CSL).

As shown in Figure 7, no clear relationship was observed between average debonding depth vs. elapsed time from concrete placement within the PVC access tubing. This was reinforced by the statistical analysis of the debonding data for the PVC access tubing, which showed wide variations between debonding depths within individual combinations for any given shaft.

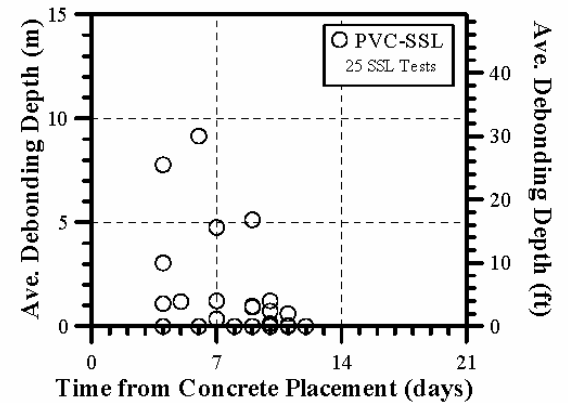
Figure 8. Average Debonding Depth vs. Time (PVC-SSL).

Analysis of the average tube debonding depth within PVC access tubing using SSL testing for this project showed that average access tube debonding depth did not significantly increase up to 12 days from concrete placement for this project. Further analysis of the statistical data showed little variation between debonding depths within individual access tube tests for any given shaft. It is unknown why the SSL testing did not show indications of access tube debonding to the extent of the CSL testing.

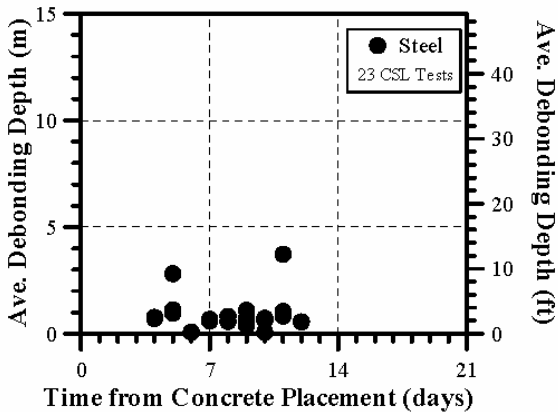
Figure 9. Average Debonding Depth vs. Elapsed Time (Steel-CSL).

Analysis of the tube debonding within steel access tubing for this project showed that average access tube debonding depth did not significantly increase up to 12 days from concrete placement for this project. Further analysis of the statistical data showed little variation between debonding depths within individual combinations for any given shaft.
