Geo-Trans 2004, the Geo-Institute Conference on Geotechnical Engineering for Transportation Projects, in Los Angeles, CA, July 27-31, 2004

SINKHOLE REPAIR UNDER HIGHWAY EMBANKMENT

Thomas J. Casey¹, PE, Member, Geo-Institute, William B. Wright², PE, Member, Geo-Institute, G. Michael Lockman³, PE, Guoming Lin⁴, PhD, PE

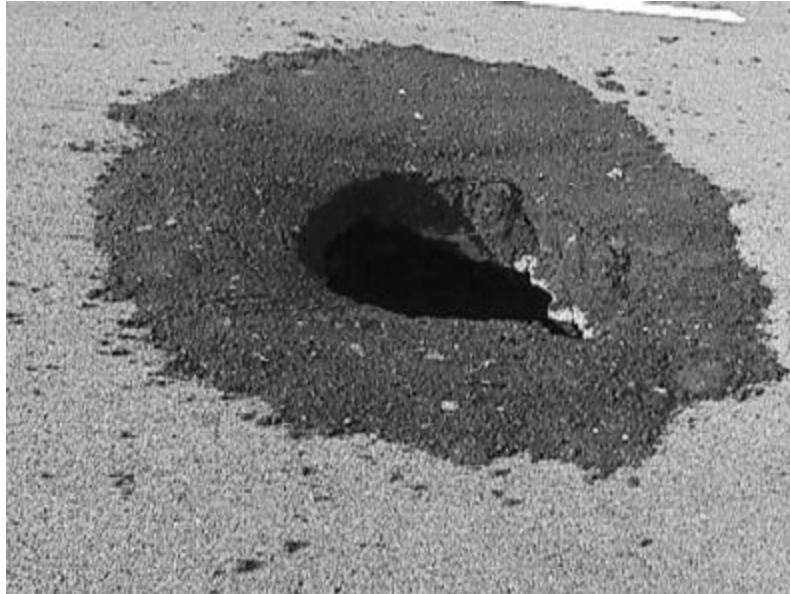
precaution, the SCDOT immediately filled the void with flowable fill (lean concrete) and patched the asphalt pavement until a detailed investigation could be performed to determine the extent of what was now identified as a sinkhole, and possible repair procedures to solve the problem. Figure 1 presents a photograph of the sinkhole prior to filling with flowable fill and asphalt patching.

Fig. 1 - Veterans Highway Sinkhole Shortly Before Initial Patching

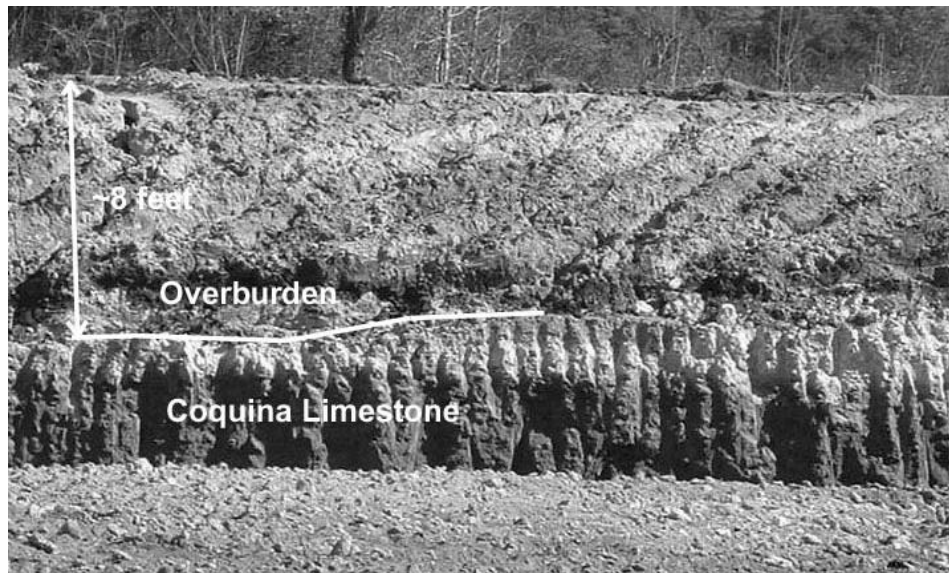
Fig. 3 – Nearby Strip Mine Excavation Showing Local Stratigraphy

The high concentration of Coquina Limestone in the Conway area can lead to problems associated with dissolution, which is typically a very slow process (Harris, 2003). Generally, the sinkhole type most prominent in the area is a subsidence type due to the thin overburden and the coquina's high porosity and past dissolution activity. Two ponds, Clear Pond and The Vineyard, located nearby, are examples of local subsidence type sinkholes that are very deep and have been filled with organics over time (Wright, 2003). Figure 3 presents a view of the local stratigraphy at a nearby strip mine excavation.
